Devon hedges and development 2: pipelines

This section gives guidance on how to reduce the impact of new pipelines on Devon hedges. Rather than being prescriptive, it sets out a series of principles that if followed carefully should ensure that damage to historic and archaeological features and disruption to wildlife is kept to a minimum, and that the landscape is not permanently scarred.

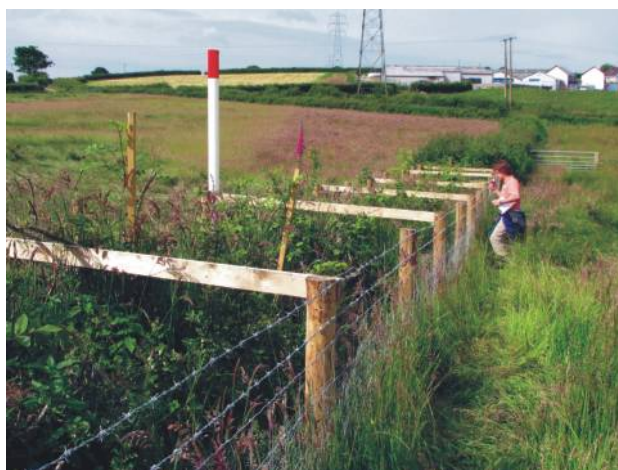
The original hedge shrubs have been replanted successfully in this Carmarthenshire hedge. A couple of saplings have been staked out to be allowed to grow into mature trees. The cross railings provide additional support for the protective fencing. ©Robert Wolton

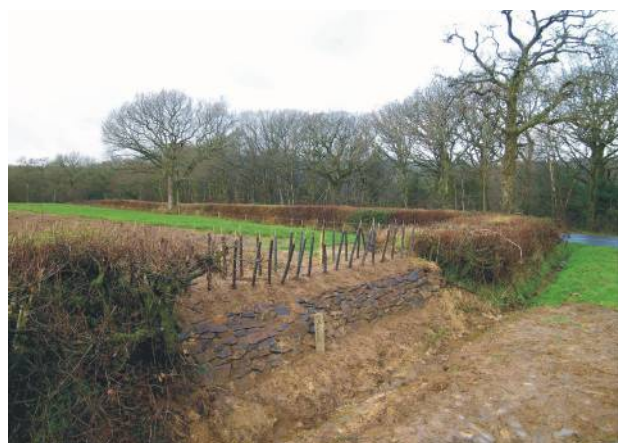
Although this section of reinstated bank is of similar dimensions to the original, there was no stone facing to begin with and the bank is taking a long time to blend in. Turf facing would have been better. The young shrubs (whips) do not mirror the species mix on either side, and were slot planted: establishment has been poor. ©Robert Wolton

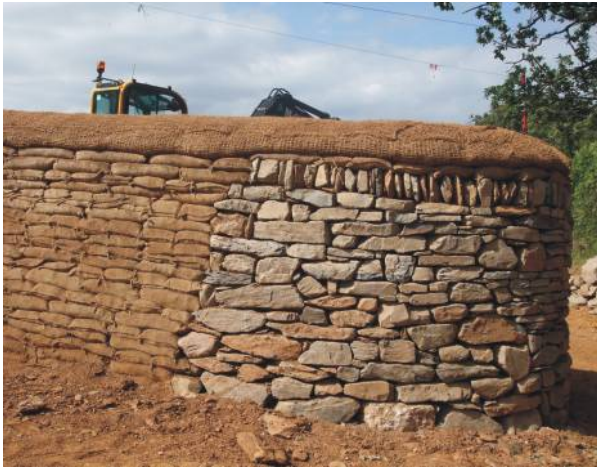
This high steep bank has been carefully restored as part of the South West reinforcement gas pipeline to match the original. Note the innovative use of hessian sacks filled with topsoil to build up the steep sides and hessian textile to stabilise the top. The original hedgebank shrubs have since been replanted successfully. ©Laing O'Rourke

This pipeline, laid between 2006 and 2008, required that over 400 Devon hedges should be breached. The contractors who laid the pipeline were Laing O'Rourke, who in turn subcontracted the management of the hedgebank reinstatement work to an accredited member of the Devon Rural Skills Trust who led a team of 27 skilled local craftsmen. The results appear very promising. A range of innovative techniques was used to reconstruct the banks to the original shape and appearance. These involved using combinations of unprotected compacted earth, hessian textile laid over

the surface of the soil (and secured by biodegradable pegs), pre-seeded soil-filled hessian sacks and stone facing. Drawing on this menu of techniques, banks of varying heights and batters could be recreated accurately, including some with steep sides over 2 m high. Banks were planted with mixes of cell-grown shrubs matching those originally present. Early indications are that the banks have a high degree of stability, and that the new hedgebank sections will blend back rapidly into the surrounding landscape.

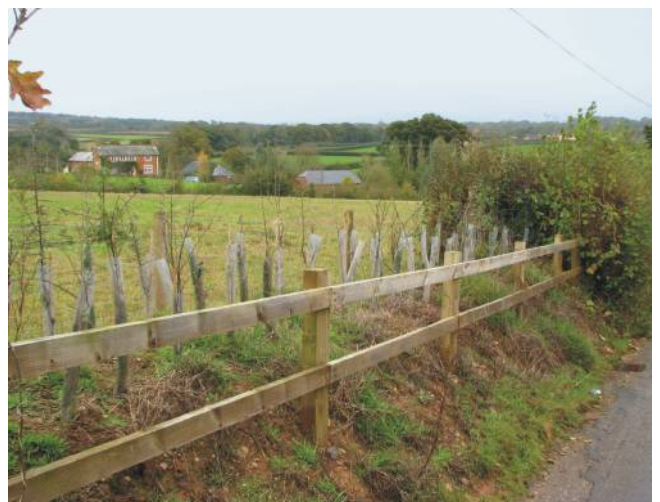
The species mix of shrubs planted in this newly-reinstated roadside hedge closely reflects that which was originally present. The shrubs have been carefully planted and establishment rate has been good. ©Laing O'Rourke

Try and replace the original shrubs wherever possible. If they cannot be used, perhaps because they are moribund, have poor rootstocks or died during removal or storage, then new planting will be needed. Use young shrubs grown from locally collected seeds or cuttings and the species mix should closely reflect that originally present. Planting should reflect the thickness and structure of the adjacent hedge, although tree species such as oak and ash and poor hedging plants such as willow, sycamore or elder may be left out.
